# **Selected Images of the Effects of the October 15, 2006, Kīholo Bay-Māhukona, Hawai‘i, Earthquakes and Recovery Efforts**

Data Series 506

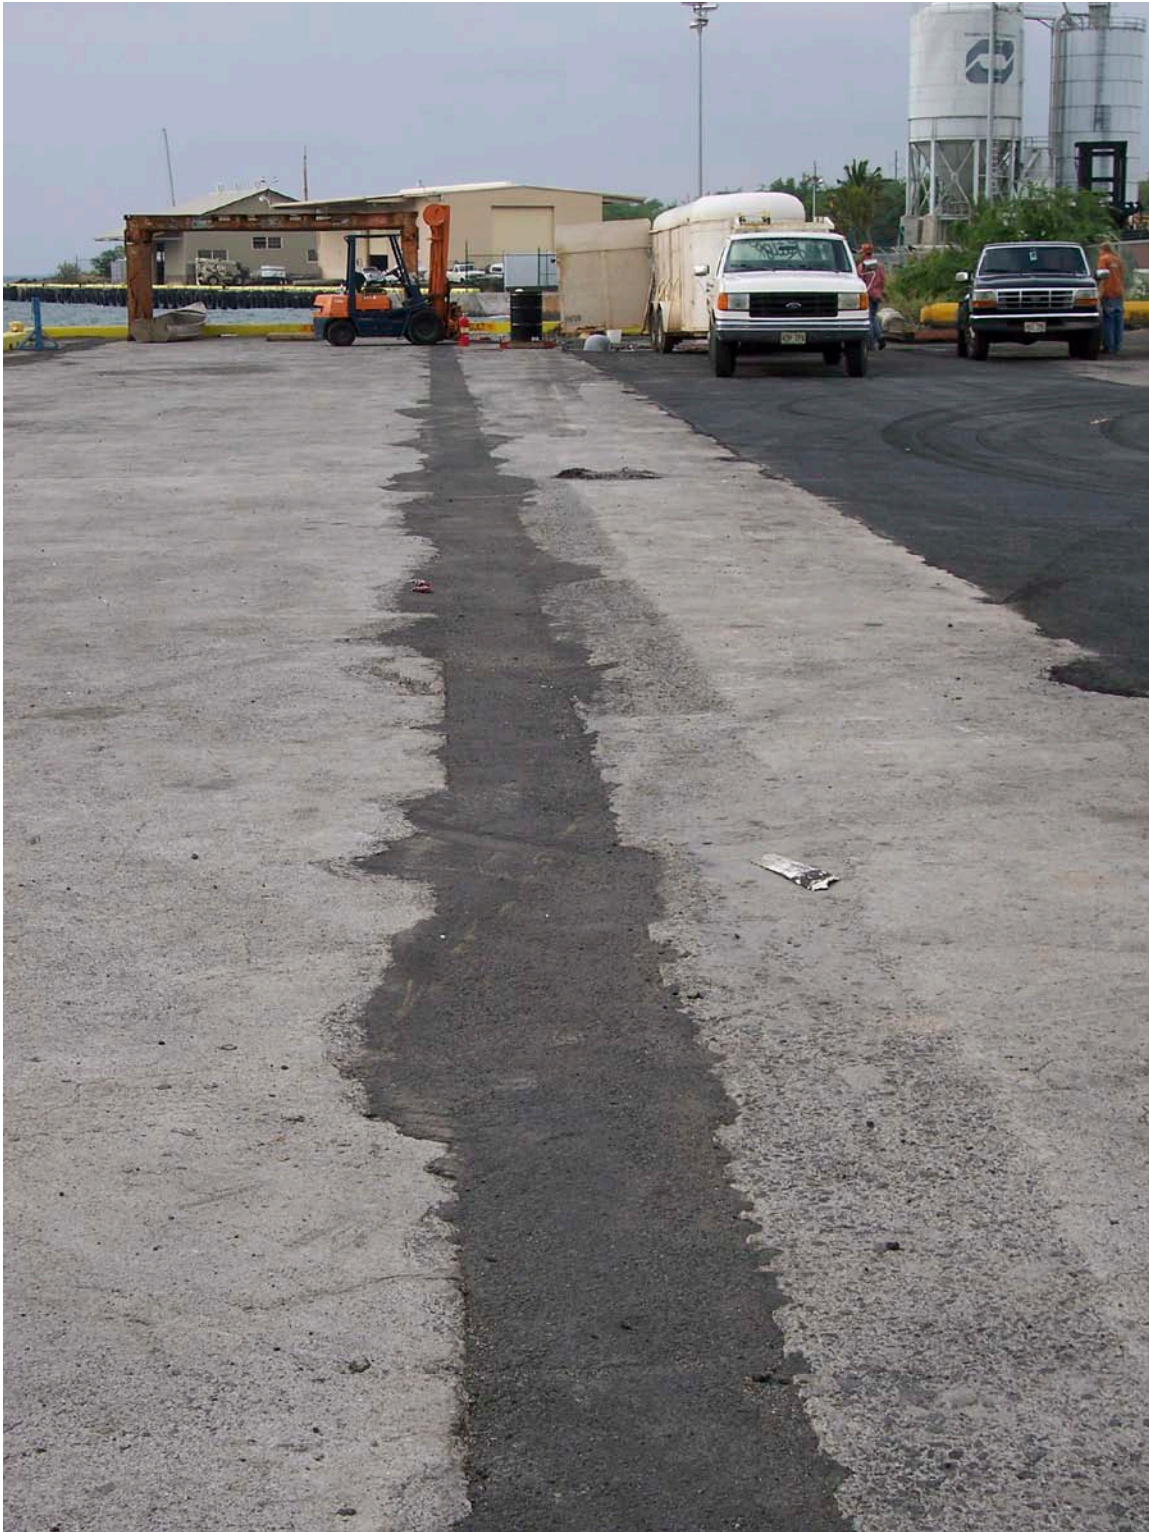
29.1. View of laterally spreading crack, approximately 0.3-m wide (1 ft), of the asphalt pavement at Kawaihae Pier 1 shipping yard, built upon dredged fill. The crack, 3.3 m (10.8 ft) deep, runs the length of the 145-m- (477-ft) long pier (view to the northwest). USGS photo by T.J. Takahashi, 10/20/2006 (tjt1419).

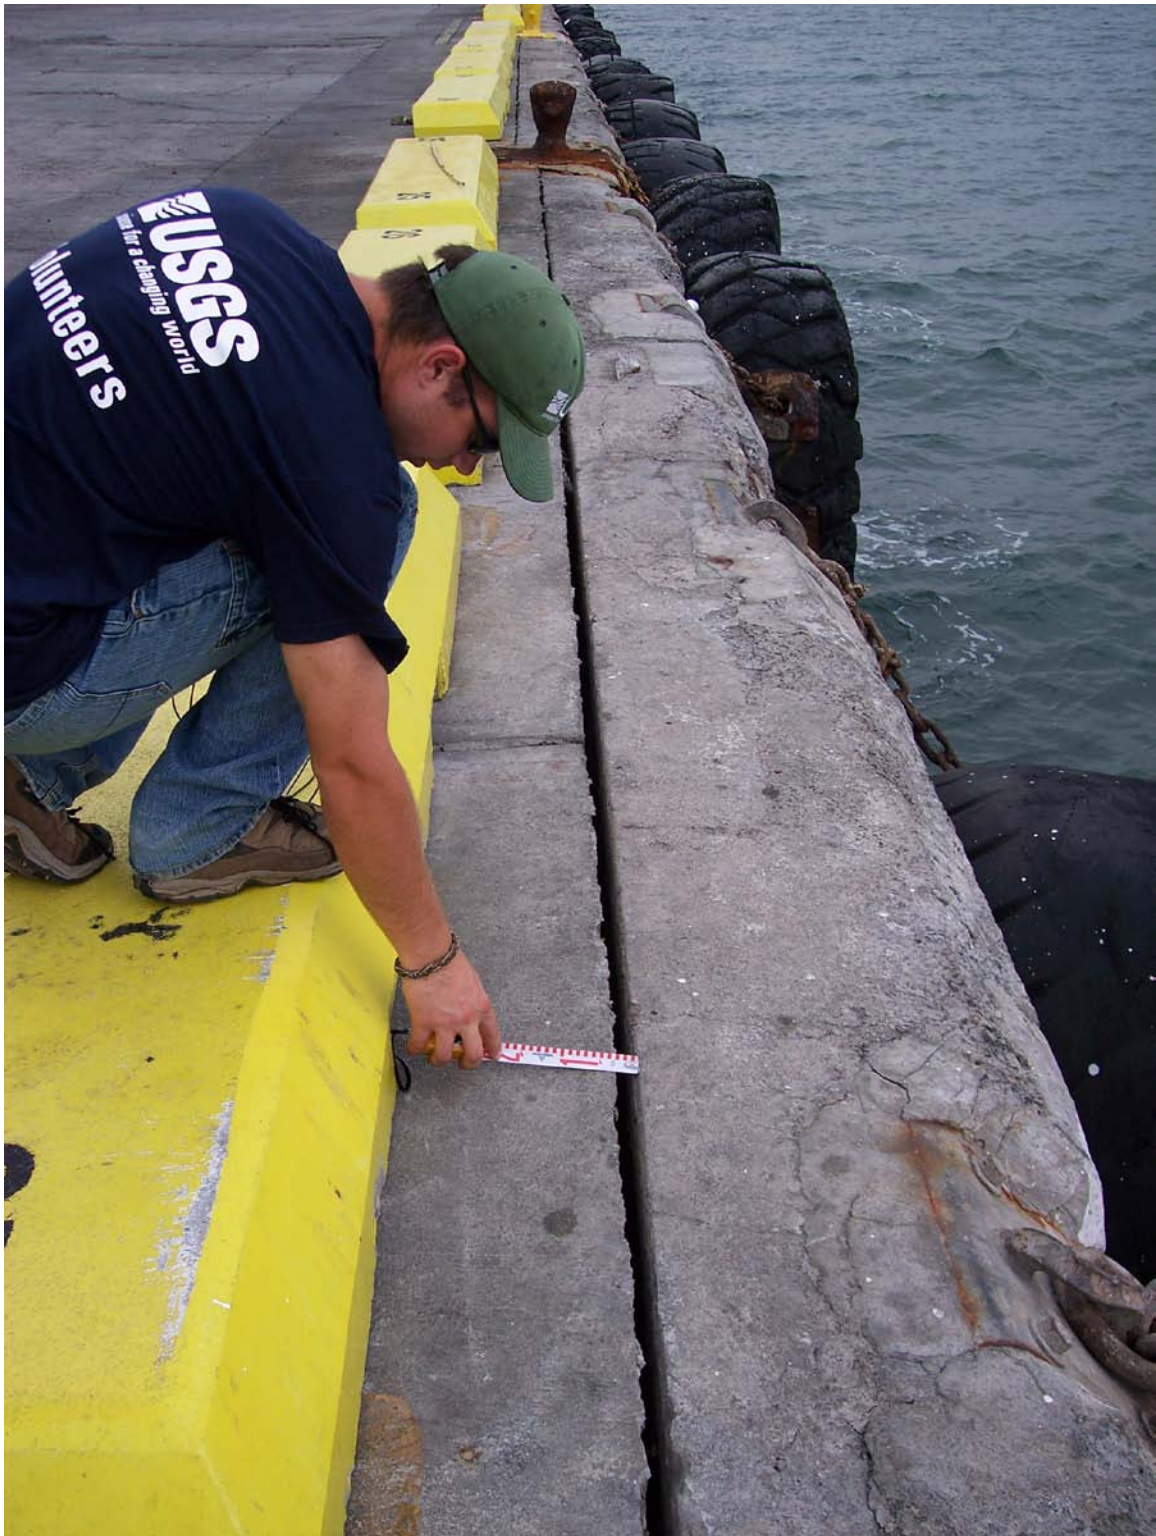
29.2. View of lateral spreading, approximately 3-cm wide (1.18 in.), of the edge beam at Kawaihae Pier 1, which was built upon unconsolidated gravelly sand (view to the south). USGS photo by T.J. Takahashi, 10/20/2006 (tjt1422).

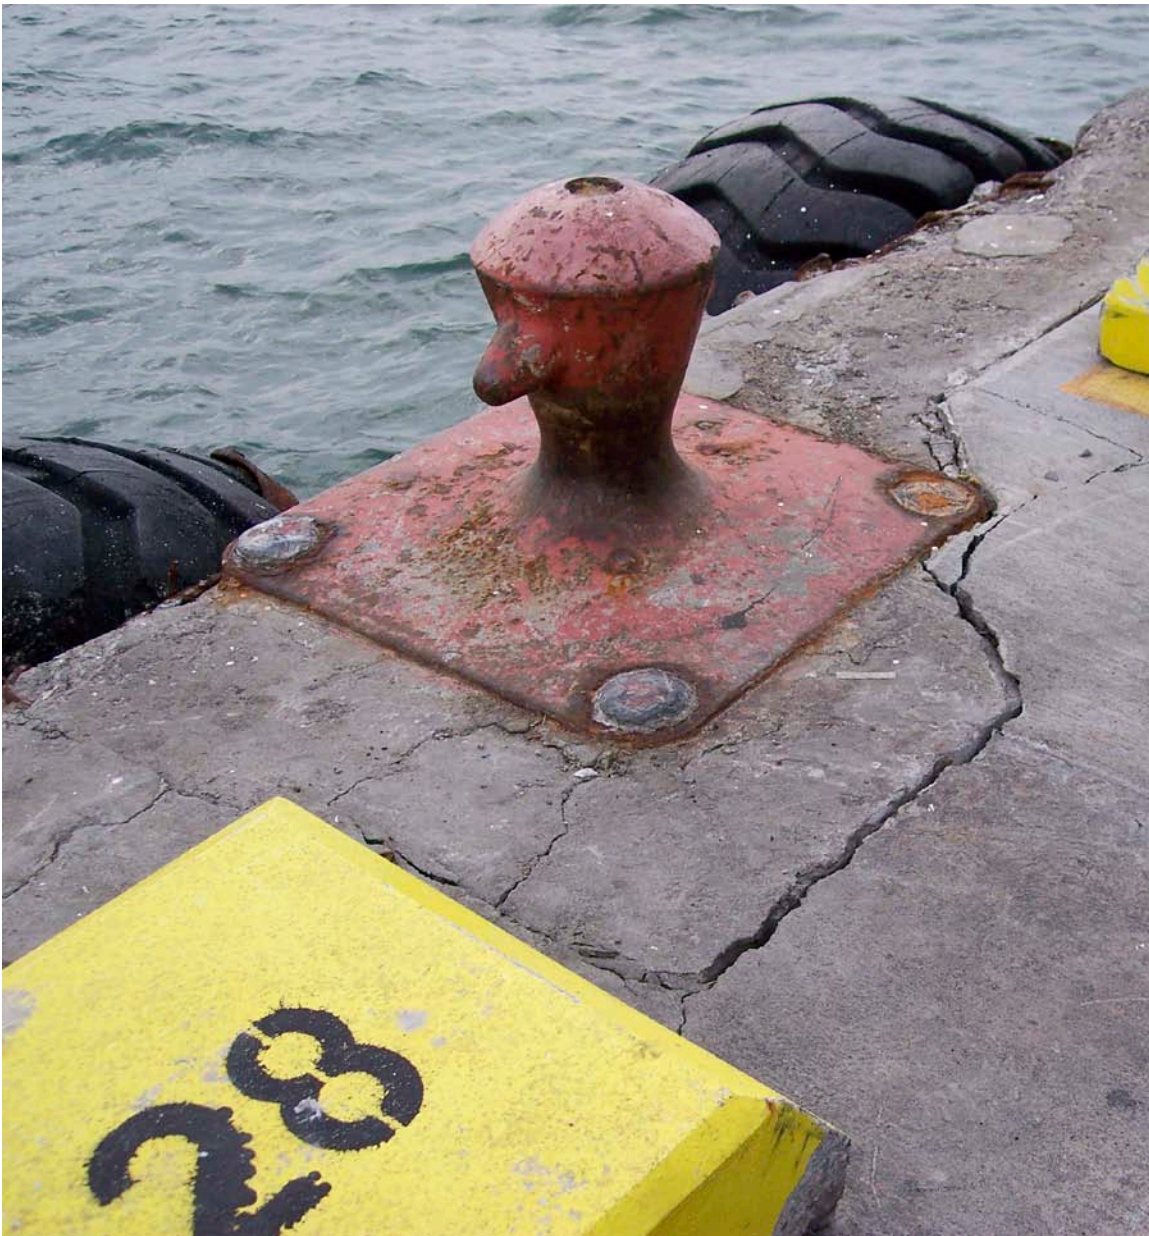
29.3. View of a torsional crack in the pavement surrounding the boat tie at Kawaihae Pier 1 (view to the northwest). USGS photo by T.J. Takahashi, 10/20/2006 (tjt1420).
